COUNCIL ACTION FORM

AGENDA TITLE: PNC Roof Replacement – 111 High Street

PNC Budgetary Wall & Roofing Assessment

Title: Building Exterior (Wall & Roof)

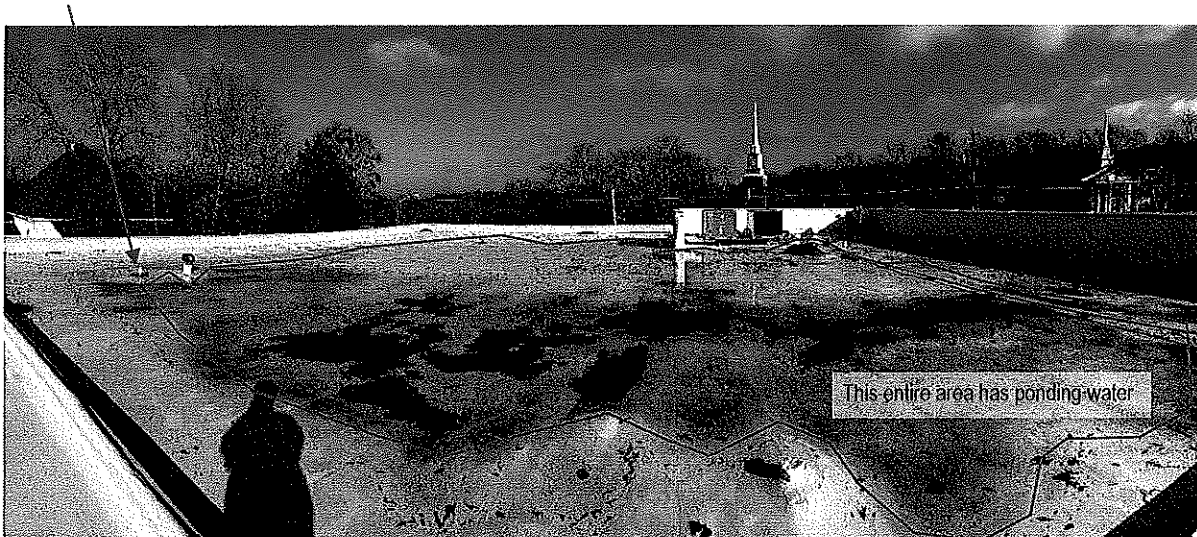
Though the membrane itself has more life in it the installation is problematic, leaving large areas of ponding water. The insulation does not slope to direct water to the drains. Several soft spots were felt where insulation below has been compromised. The combination of the amount of water being retained along with the soft spots discovered leaves me concerned that some areas of the cementitious wood fiber plank roof deck may be compromised and portions may need to be replaced. This condition was observed in large areas of the roof and was not contained in an easily isolated portion.

Note: standing water over almost entire roof. The building has a sufficient number of drains however the insulation is not tapered to the roof drains. Drains inlets sit raised above the average surface height of the roof membrane. The red arrow points to one of the roof drains.

Our recommendation is that a new membrane roof should be installed with insulation sufficient to meet the current GA energy codes and properly tapered to insure rainfall flows to drains. We expect the tear off of the existing membrane and insulation and the installation of a new commercial grade TPO roof with tapered insulation to be @ \$16 a square foot installed. Based on the 6,672 square foot area of the building, we recommend that the city budget \$107,000 for replacement.

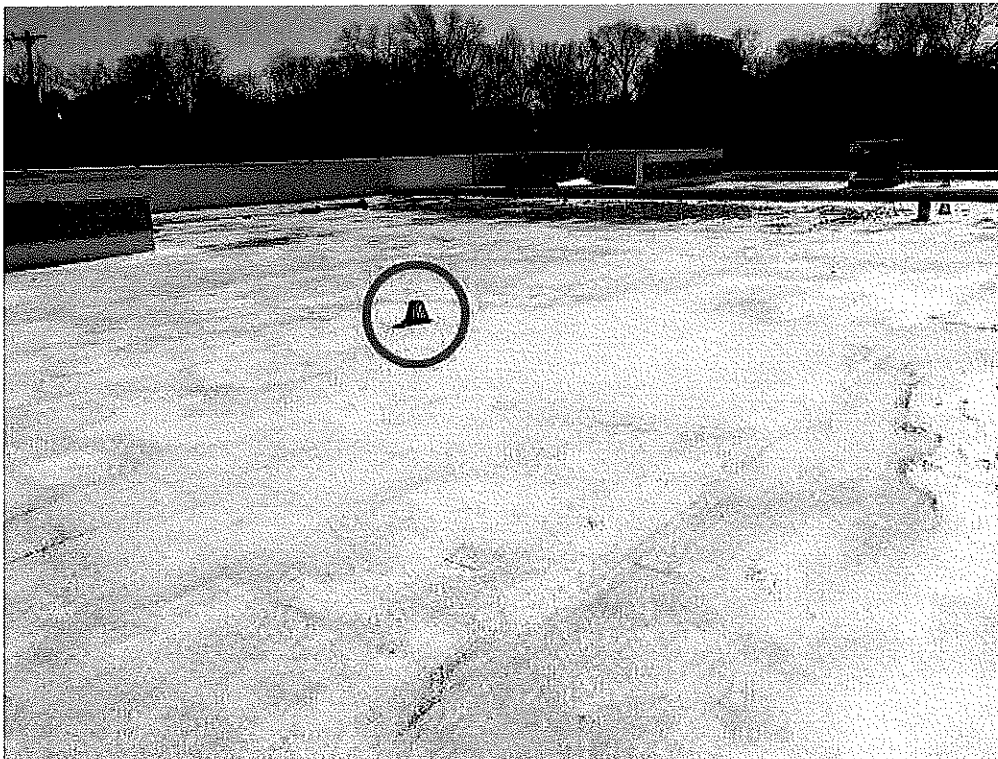
Photo 1

The existing roof is made up of a single-ply membrane either a TPO or PVC with internal roof drains.

Red circle shows single roof drain in the middle of the roof.

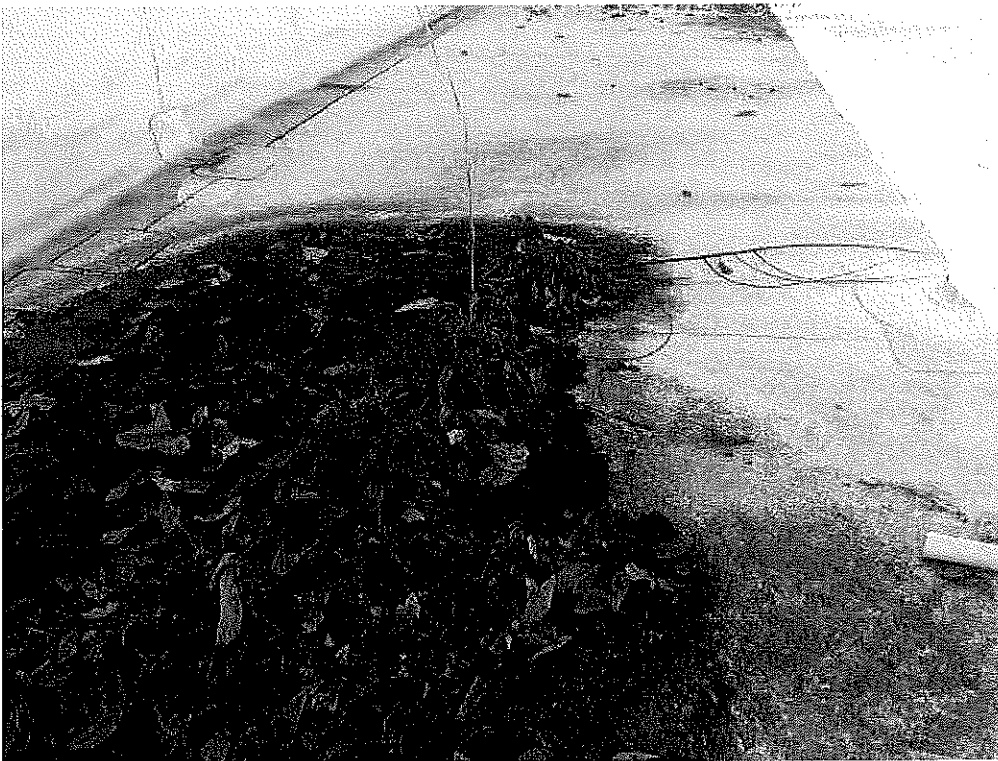
Photo 3

Large amounts of vegetation have taken root in low lying areas of the roof. This is due to ponding water. Ponding water occurs when the roofing system does not adequately shed rain water to the internal roof drains. Low lying areas will continue to add weight to the roofing system, compressing the insulation making ponding worse over time while adding undue weight to the building structure. This combined with vegetation growth, drastically shortens the life of a roof and can cause unsafe working conditions.

- Add crickets throughout roofing system to allow for adequate drainage to internal roof drains
- Add sumps to every internal roof drain
- Adhere 1/4" recovery board in accordance to engineered wind up-lift calculations

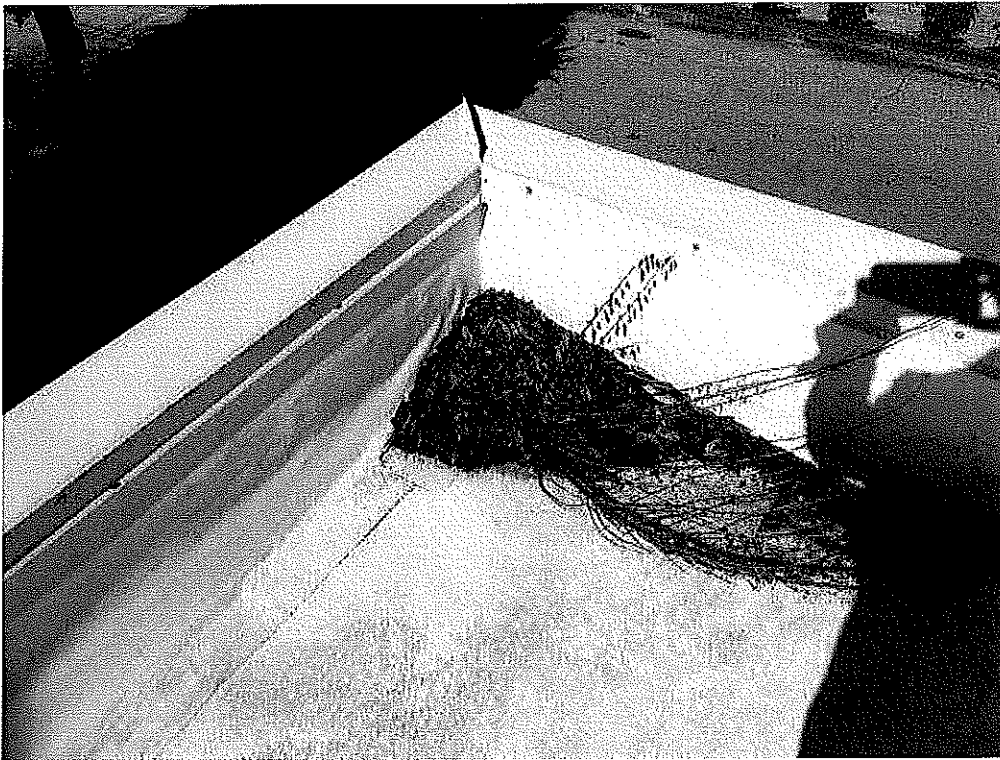
Photo 4

More vegetation.

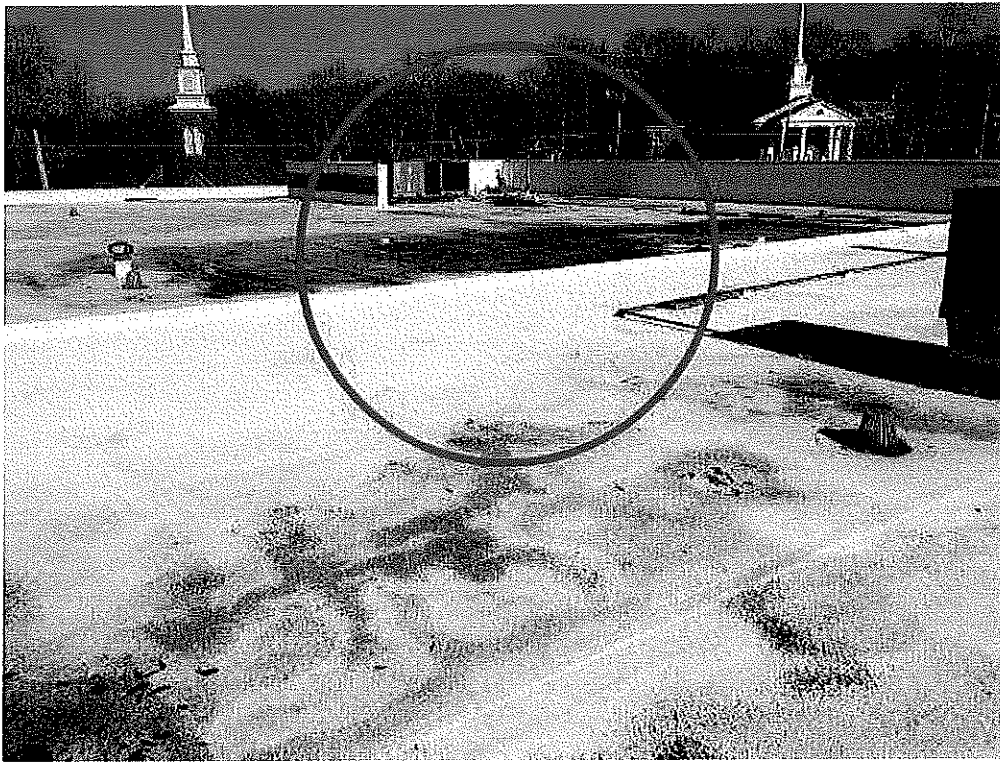
Photo 6

Red circle shows large area of ponding water.

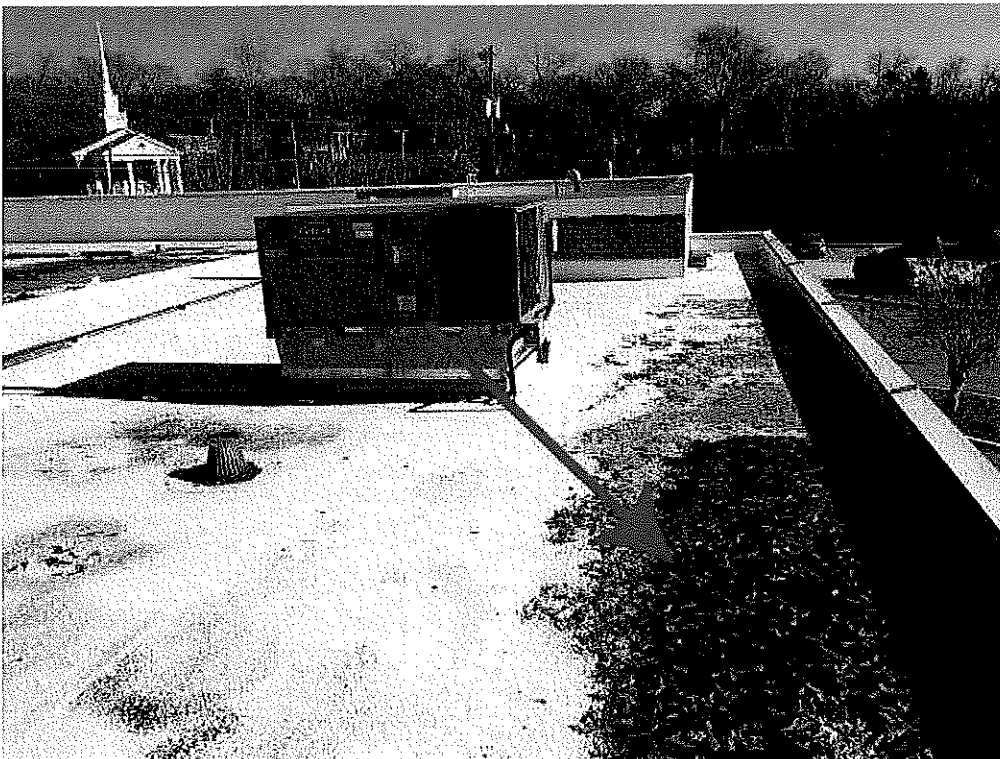
Photo 7

Red arrow shows more ponding.

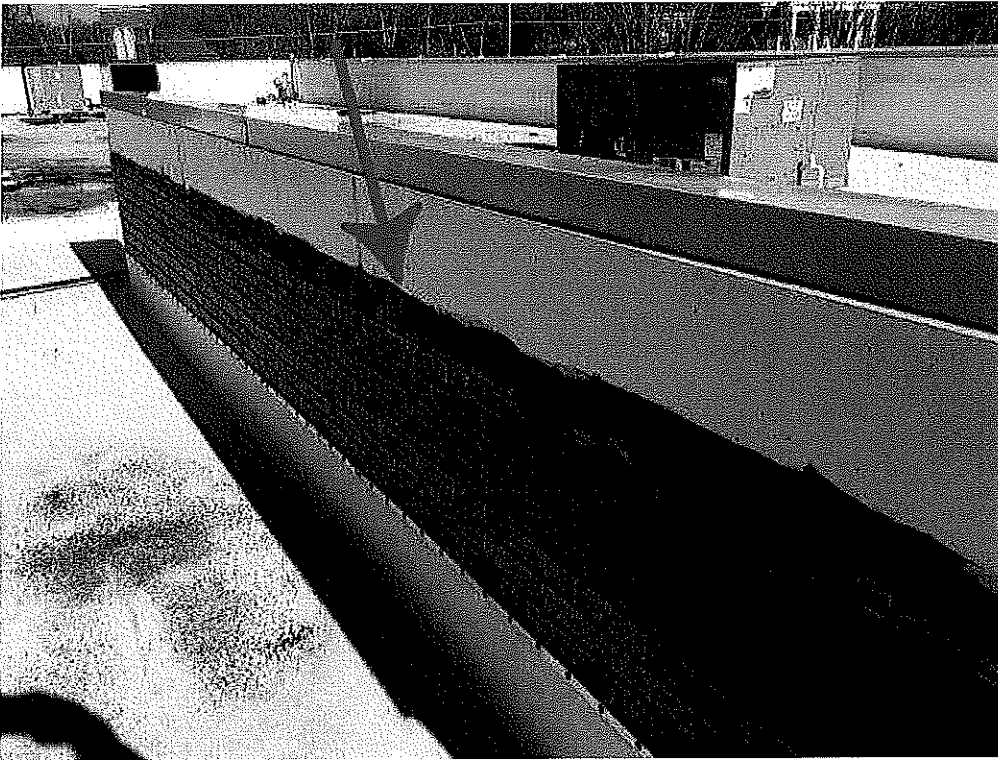
Photo 8

Attempts have been made to repair brick parapet wall.

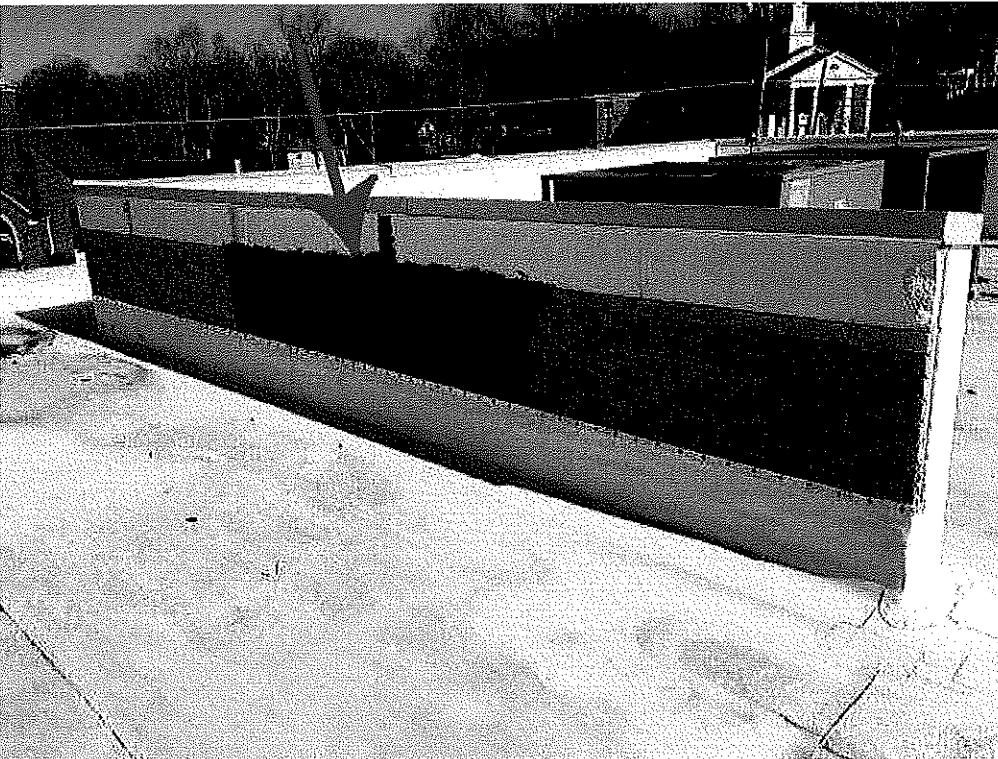
Photo 9

Another wall with temporary repairs.

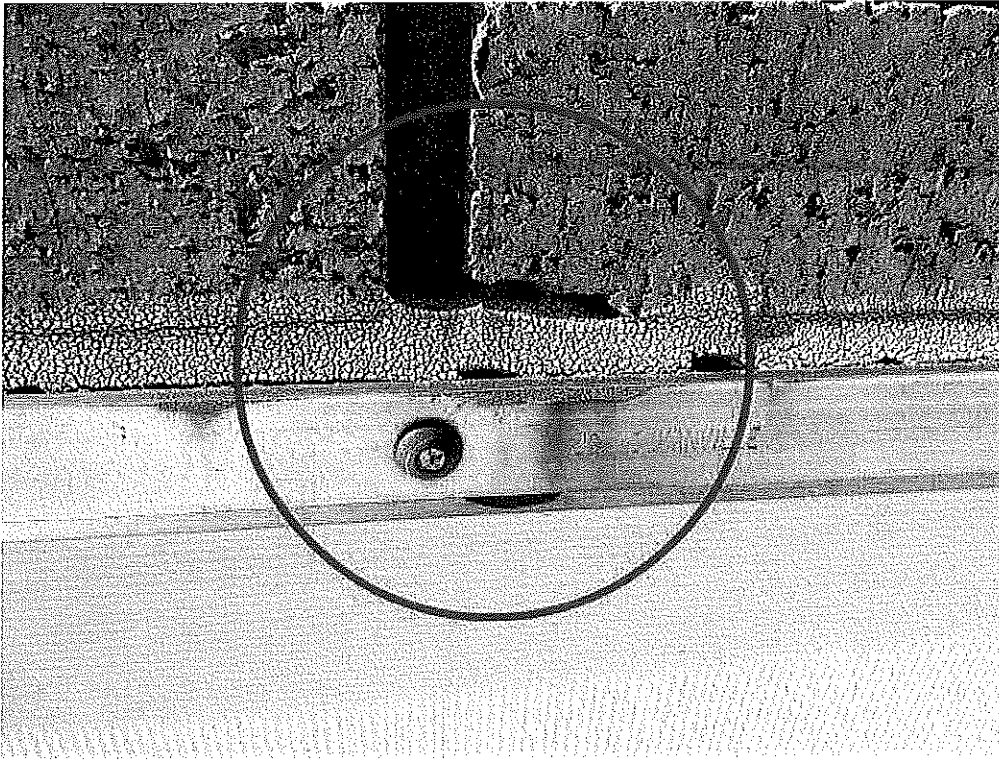
Photo 10

The metal plate that runs left to right just under the brick is called a turn bar. A turn bar is what anchors the single-ply to the wall. This method did not include a surface mounted counter-flashing which, when not used, exposes the sealant above the turn bar to the elements. Over time, it breaks down as seen here, and allows water to enter the building.

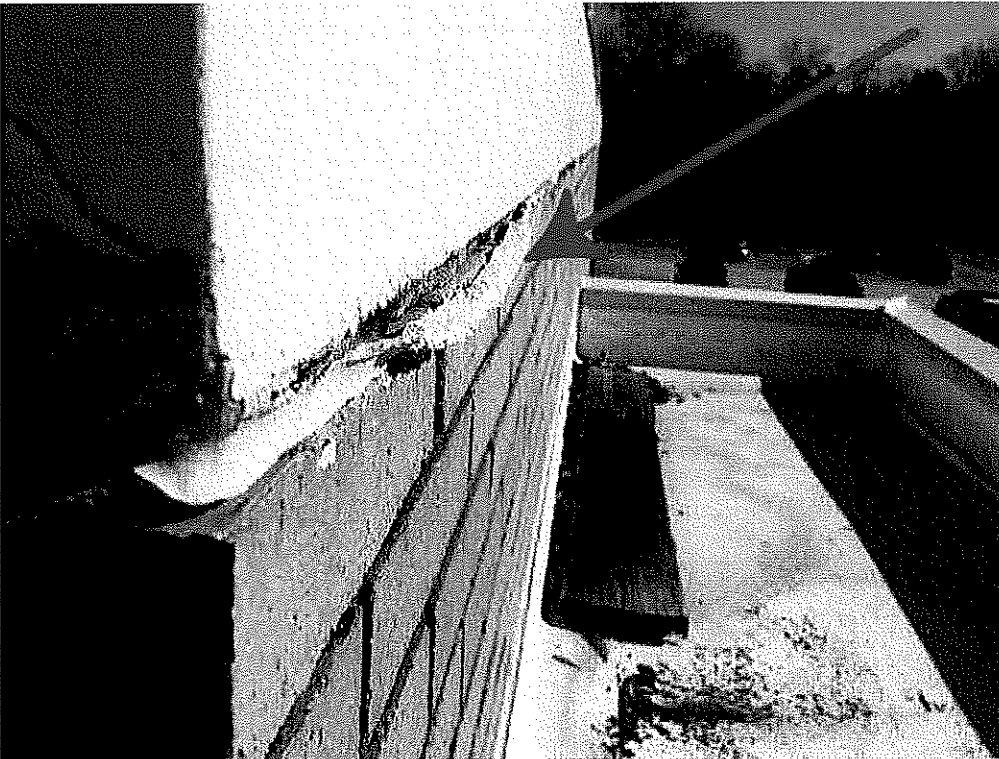
Photo 11

Red arrow shows where the sealant has deteriorated and come loose from the joint. Water can now easily enter into the brick wall weakening the system while causing leaks in the building.

- Pressure wash removing all dirt, debris, contaminants, mold and mildew from building exterior
- Remove all old sealant from expansion, cove, and waterproofing joints
- Apply backer rod and caulk to any gaps larger than 1/4"
- Re-tuck any loose or missing mortar joints
- Apply (2) layers of sealant on building exterior
- Contractor to provide (2) YR workmanship warranty upon completion and acceptance
- The Garland Company to provide (10) YR material warranty upon completion and acceptance
