COUNCIL ACTION FORM

AGENDA TITLE: PNC Roof Replacement – 111 High Street

PNC Budgetary Wall & Roofing Assessment

Title: Building Exterior (Wall & Roof)

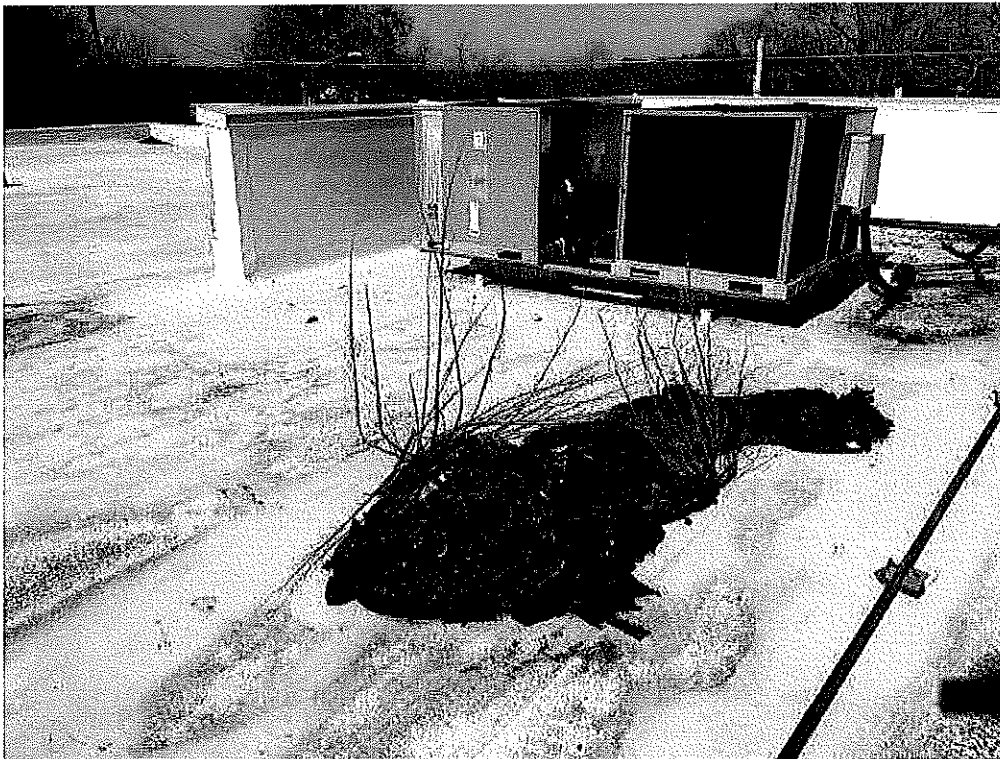
Photo 4

Large amounts of vegetation have taken root in low lying areas of the roof. This is due to ponding water. Ponding water occurs when the roofing system does not adequately shed rain water to the internal roof drains. Low lying areas will continue to add weight to the roofing system, compressing the insulation making ponding worse over time while adding undue weight to the building structure. This combined with vegetation growth, drastically shortens the life of a roof and can cause unsafe working conditions.

More vegetation.
